DROUGHTPROOFTXAS

Flood and Drought Mitigation

DROUGHT PROOF TEXAS - MISSION

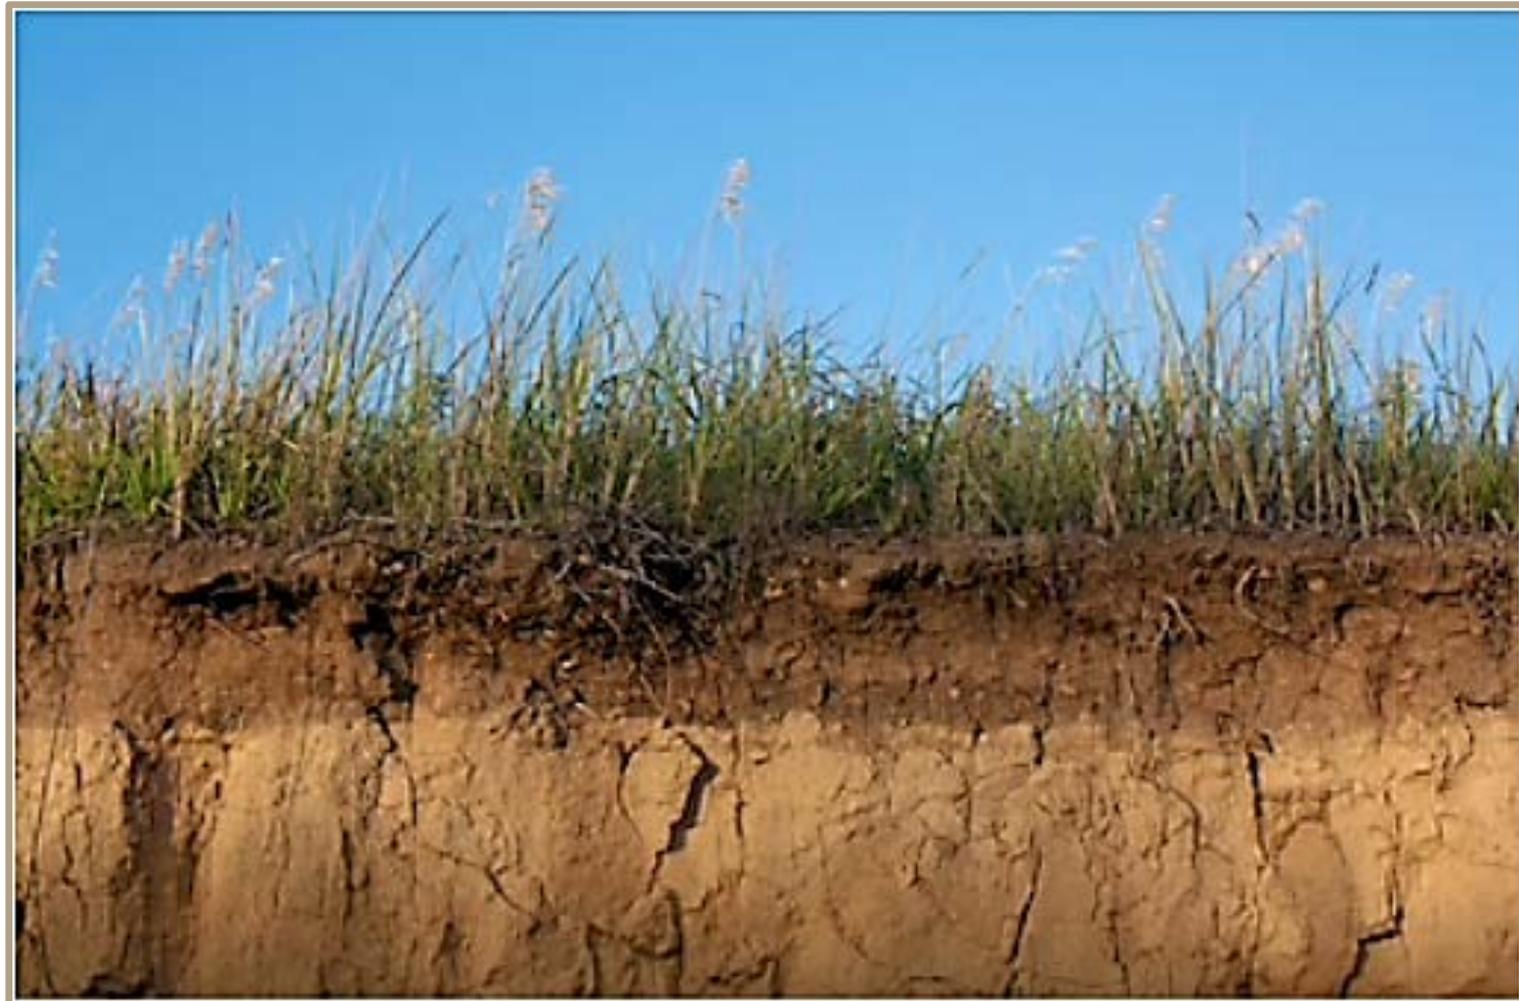
SOIL FERTILITY

During photosynthesis, plants split the water molecule and exhale oxygen, which we breathe. The remaining hydrogen is used to create sugars that the plant uses as food to maintain and grow its own body.

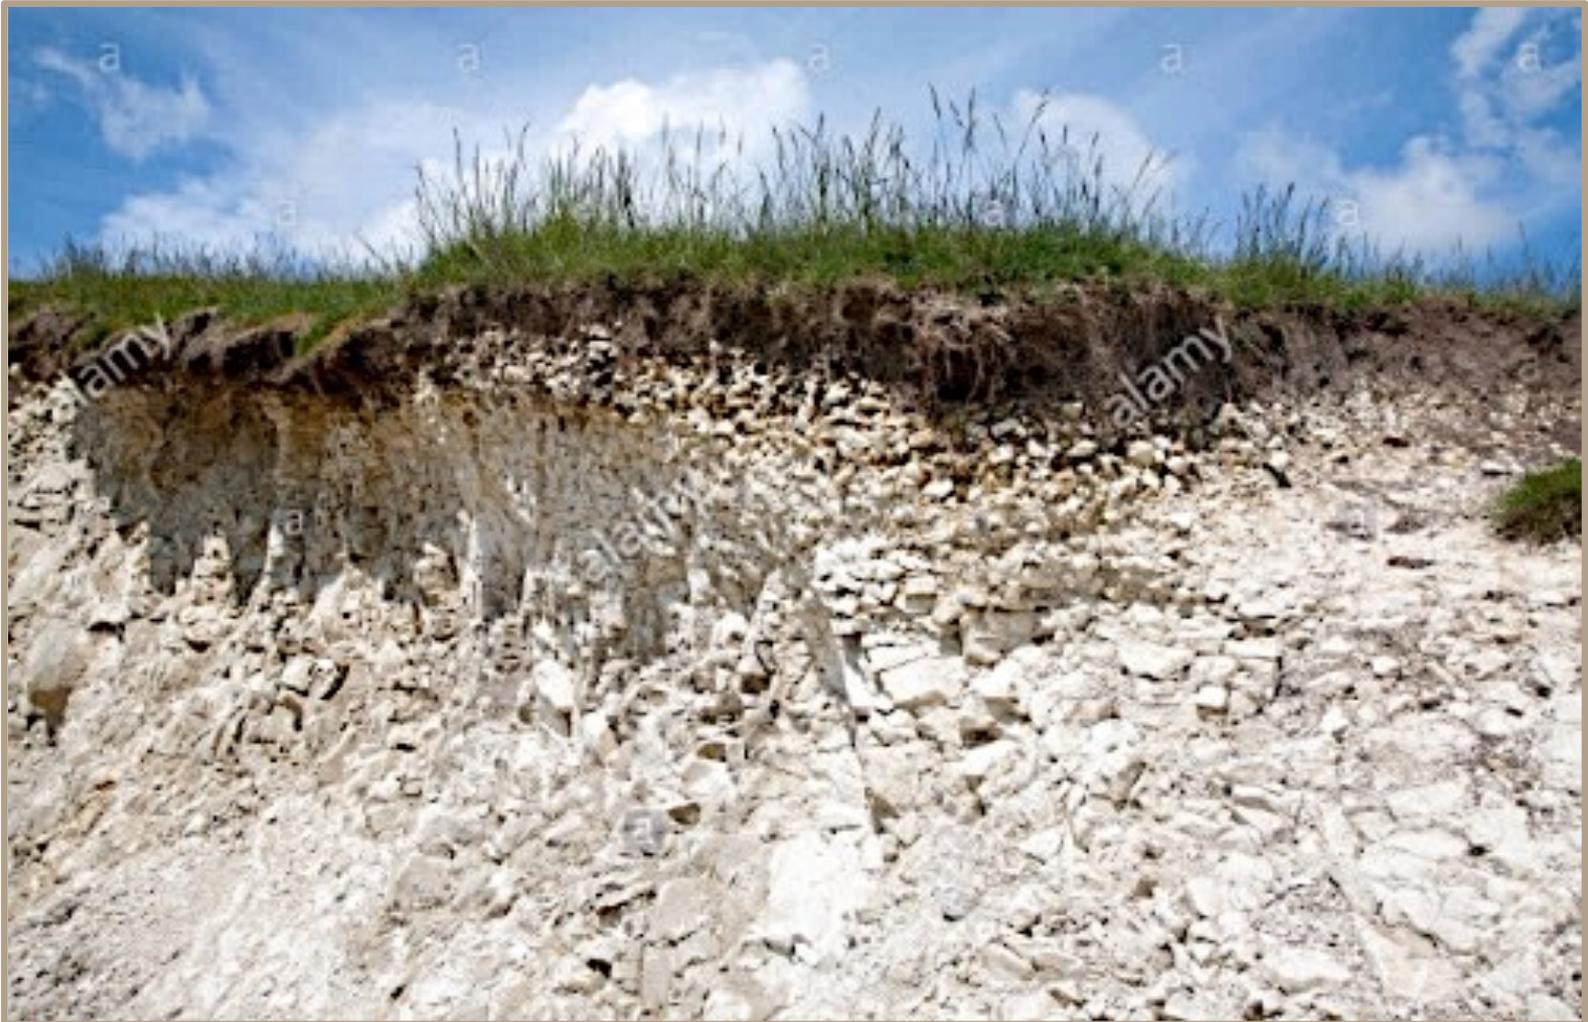
SOIL FERTILITY

During good conditions plants will produce more food (sugars) than they need to. This excess is known as liquid carbon which drips from tips of the plant roots as root exudates.

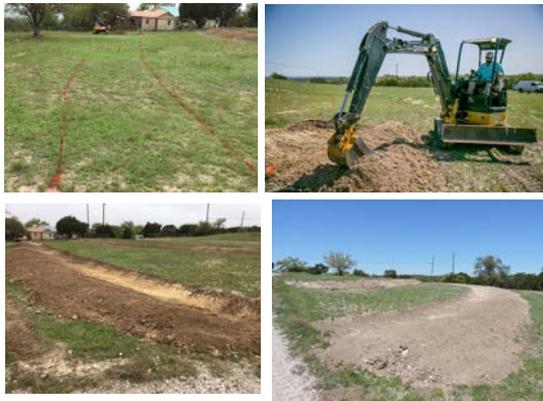
Runoff Management

The 3 acres of catchment can receive 80,000 gallons in one inch of rain with no runoff. This system has absorbed all runoff and not overflowed since installation in early 2016, for a cost of \$5000.00. Soaking water into the hills can help mitigate flooding lower in the watershed. The following photos show the system as its being built and the freshly excavated bio-swales.

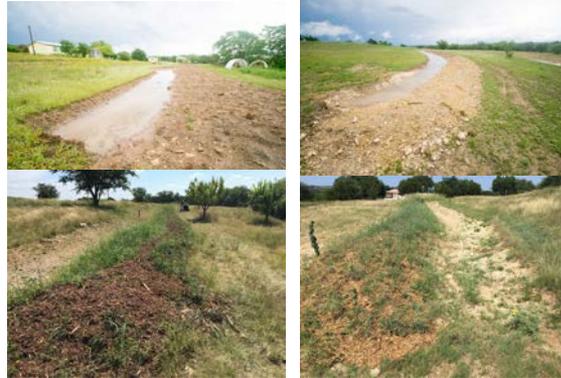
Water Conservation

These bio-swale structures were built to last for 100 years or more. Over a 25-year period, using an average rainfall of 35 inches, this 3-acre system has the potential to harvest 70,000,000 gallons (212 acre feet). This extra water has been put to use serving the farm ecosystem. The berms are being managed as a poly-cultural orchard, with a ground cover of native grasses and pollinator forage. The system will pay for itself with a bounty of fruits and cut flowers. The alleysways are being managed by chickens and the farm is already having great success selling their meat and eggs to local restaurants. The following photos show how the bio-swales catch runoff, water soaking into the berms, the mulch covering and the first seedlings coming up. As the project matures native trees and fruit trees will grow to shade the terraces and grazing alleysways, this will help keep the ground cool and prevent evaporation.

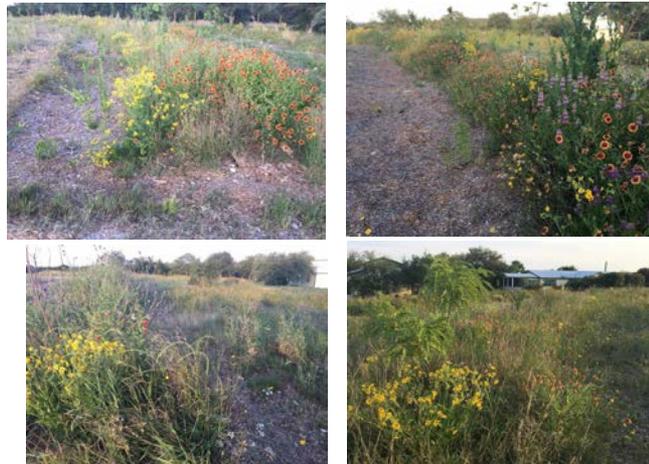
Pollinator Forage & Habitat

The berms of these bio-swales were built to be strong but able to grow things easily, like a long garden bed. The extra moisture from the basin and the garden bed tith gives the native grasses, wildflowers, cover crops, and trees the perfect growing conditions to thrive, in this context. The structures were seeded with over 60 different native plants. The results in one year were incredible. The berms were covered 100% with thick vegetation, both native grasses and wildflowers grew to sizes that we had not anticipated in this soil type. The alleysways also have also shown great improvement in plant diversity. Where there was no diversity now is a thriving ecosystem that is profitably managed by farm animals.

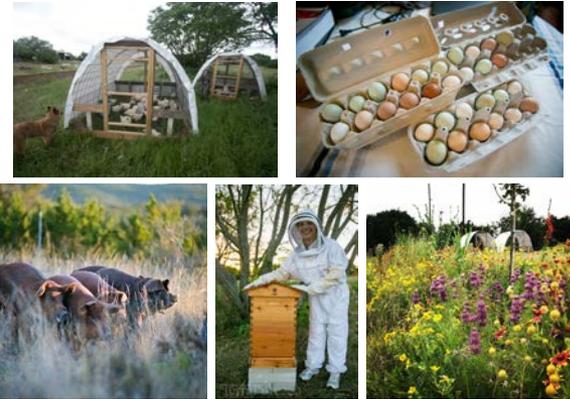
Farm Enterprises

The farmers and managers of this land, Orion Weldon and Tina Lubomira Weldon, are putting this system to work. The berms have been planted with 150 trees and shrubs. There is a diversity of fruit trees, fruiting shrubs, native legume trees, and pollinator forage trees. In the alleysways between the bio-swales they are now grazing and frequently moving chickens and pigs for sale to local restaurants. The pasture raised chicken is amazing! Rotating the animals around the property has begun to have a positive effect on the soil health. The once barren caliche in the alleysways is now growing grass and native flowering plants! The farm has acquired two honey bee hives to take advantage of the prolific pollinator forage and to supplement pollination for the fruit trees. They have also been using the berms as raised bed crop gardens growing squash, beans, and corn.

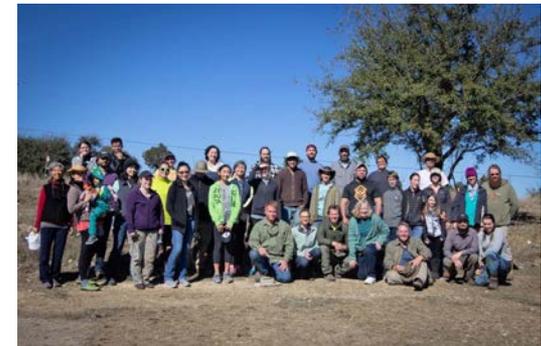
Community Outreach

This project has been functioning on the farm since April 2016. In February 2017, in partnership with Earth Repair Corps, we held an event open to the community where 45 volunteers came and planted 150 trees, spread seeds, install fencing, install irrigation for the trees, and cover the grazing alleysways with mulch at the farm. Earth Repair Corps has held over 45 educational events similar to this helping local farms, schools, and homesteads. In some cases there have been over 100 volunteers attending these events to learn about sustainable design and regenerative agriculture. During the event we had a quick tree planting demonstration, and educational talks from the farmers and President of Earth Repair Corps, Kirby Fry. Pictured below is our group photo for the TerraPurezza Farm Permacultz event. For more information about this volunteer group and educational events please visit www.earthrepaircorps.org. TerraPurezza has been tirelessly working with local restaurants and proving to them that regenerative agriculture can produce high quality products with ecological integrity. Please visit their website <http://terrapurezza.com>.
